**UNIT 1 - SPRING, 1989, OUTAGE
ENGINEERING INSPECTION REPORT**

STEAM GENERATOR - BURNER INSPECTION

OBSERVATIONS AND WORK ACCOMPLISHED

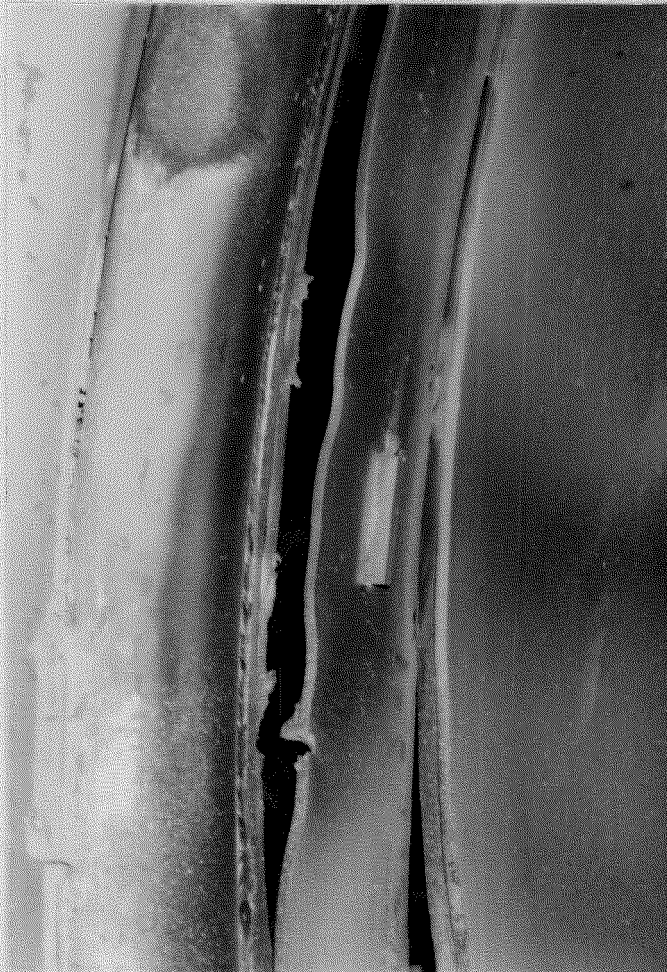
Photo 37 - Additional photo of the burner front showing deteriorated condition of waterwall to throat casing ring seal.

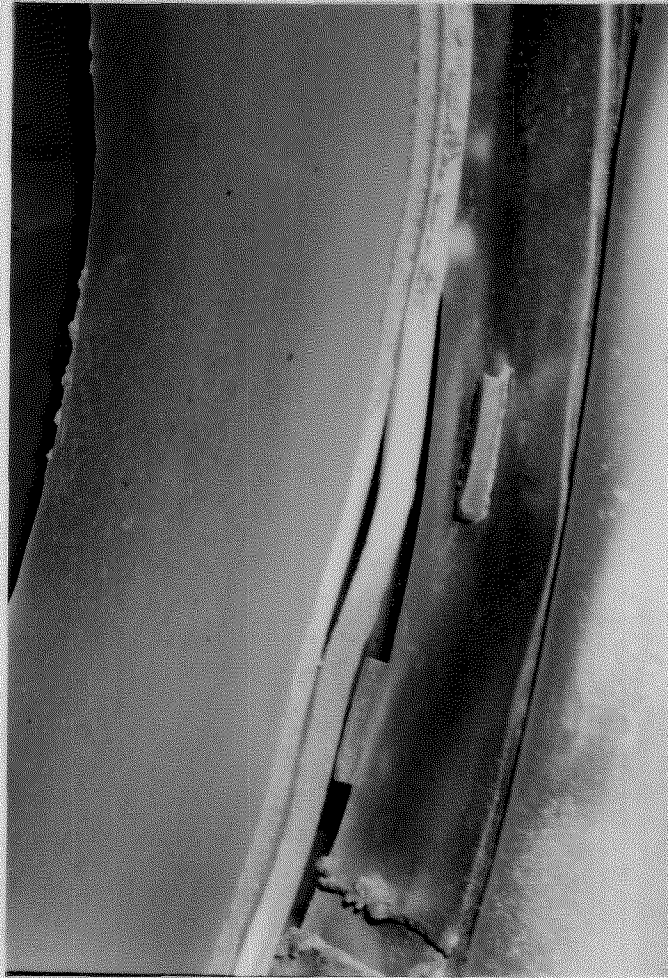
Photo 38 - Additional photo of the burner front showing deteriorated condition of waterwall to throat casing ring seal.

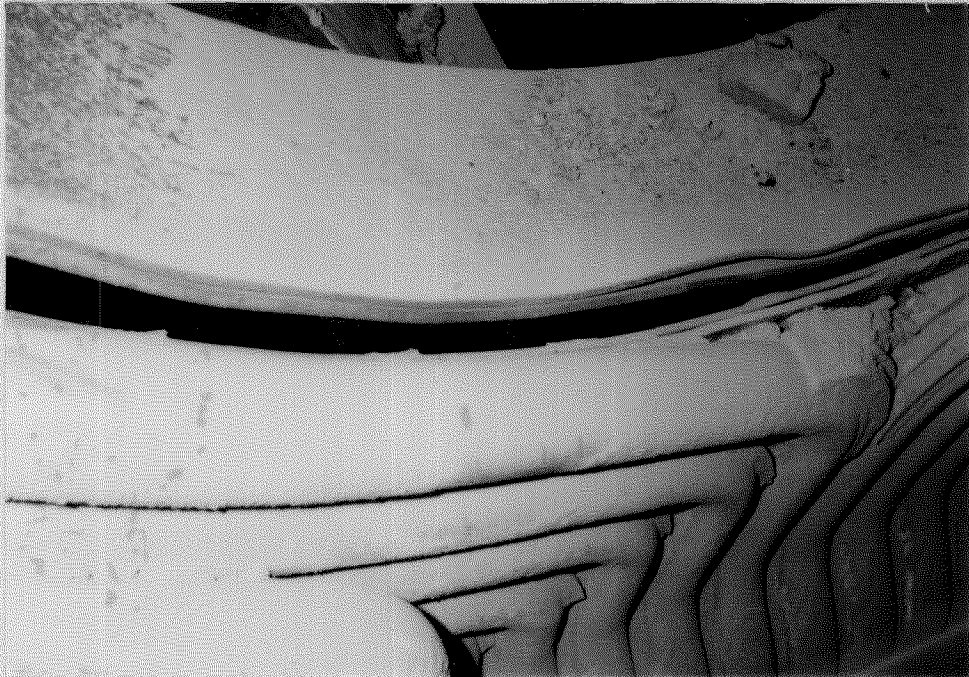
Photo 39 - Additional photo of the burner fronts showing excessive clearances around the outside of the burner assemblies.

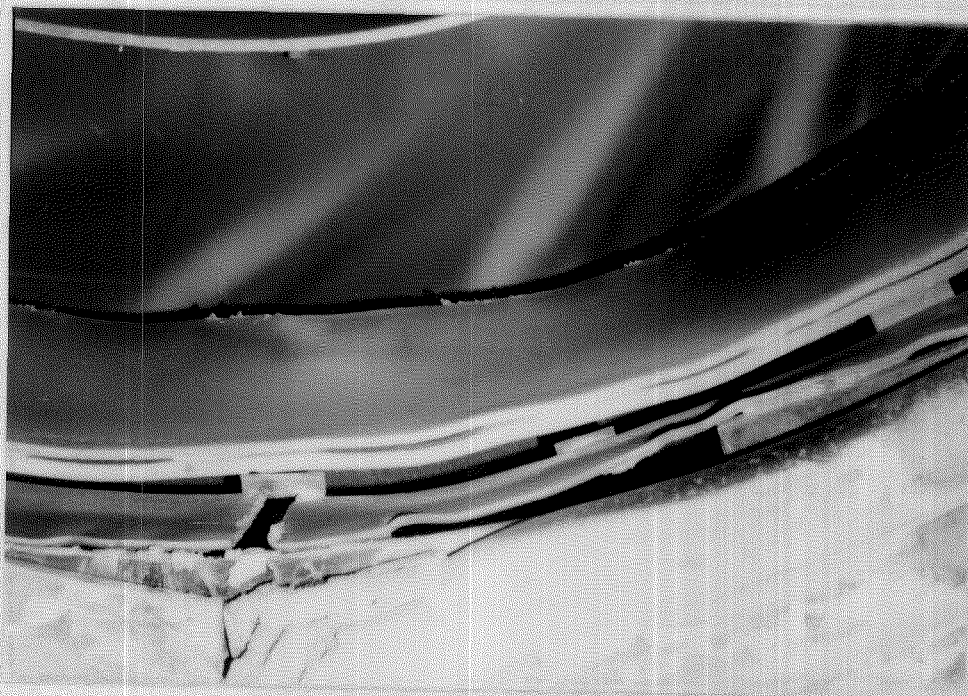
Photo 40 - Additional photo of the burner fronts showing excessive clearances around the outside of the burner assemblies.

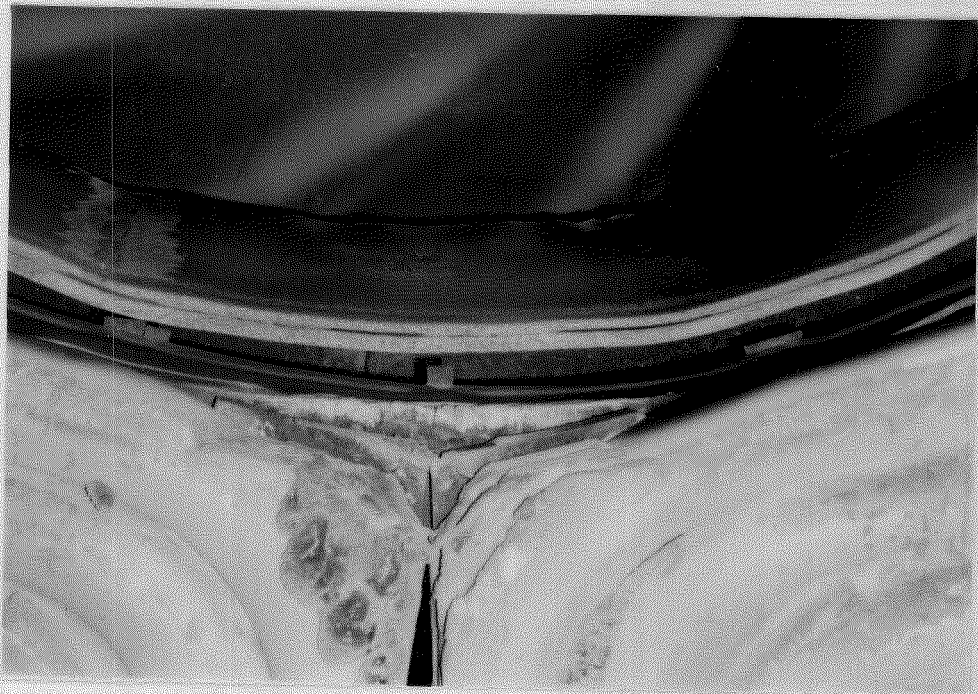
Photo 41 - Another photo, again showing the excessive gaps out around the burner front which allows maldistribution of combustion air.

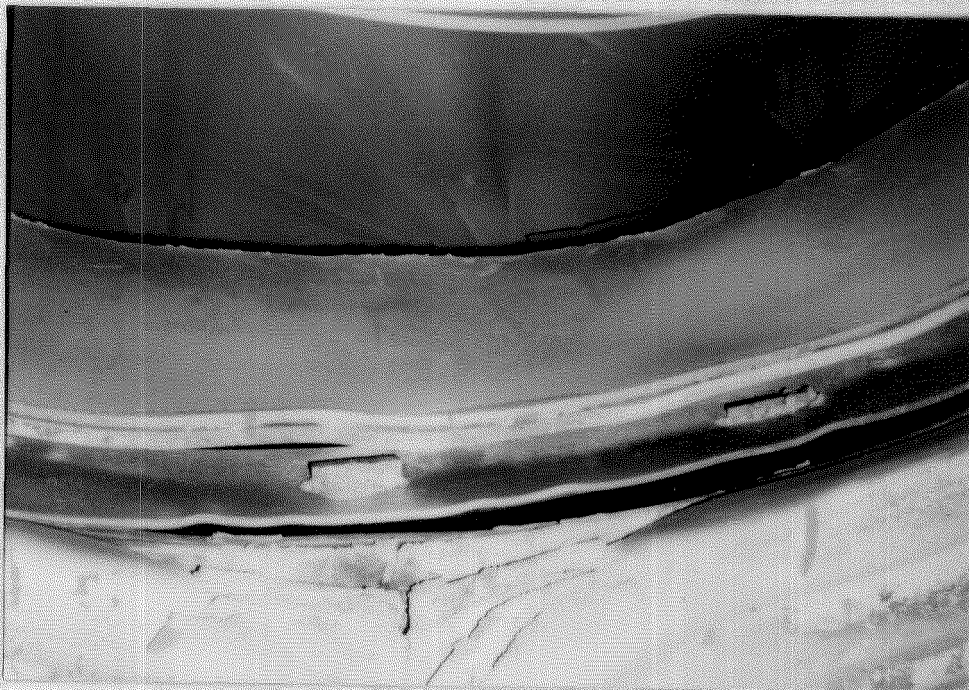
Photo 42 - Another photo, again showing the excessive gaps out around the burner front which allows maldistribution of combustion air.

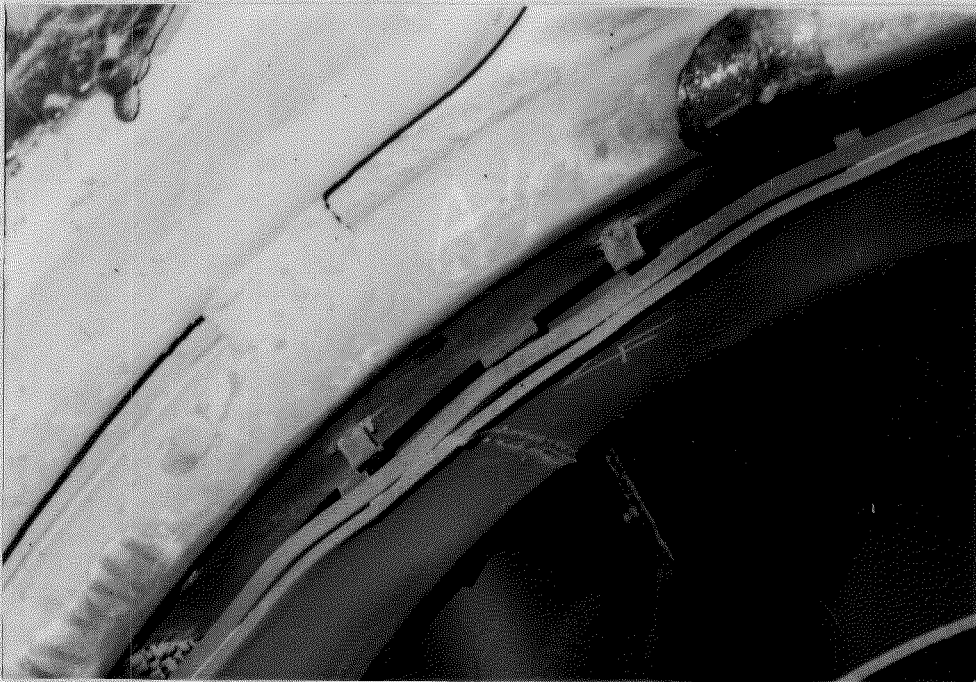
Photo 43 - Deteriorated condition of the throat sleeve casing ring on Burner 1A04.

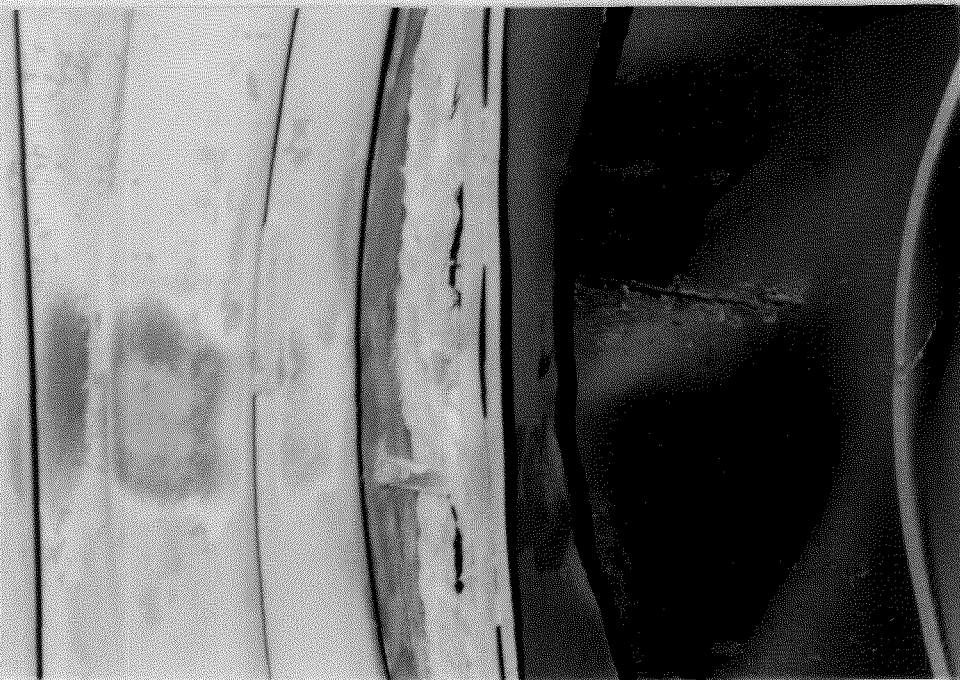
This seal is to prevent air leakage from bypassing combustion (secondary) air flow from out around the outside of the burner. It also provides a seal to prevent fly ash, coal and fuel oil from being reentrained (licked-back) back into the windbox (reference Photos 31 and 44).

Photo 44 - One of the few burners which still has remnants of the rope packing seal originally designed to provide an air tight burner to waterwall seal.

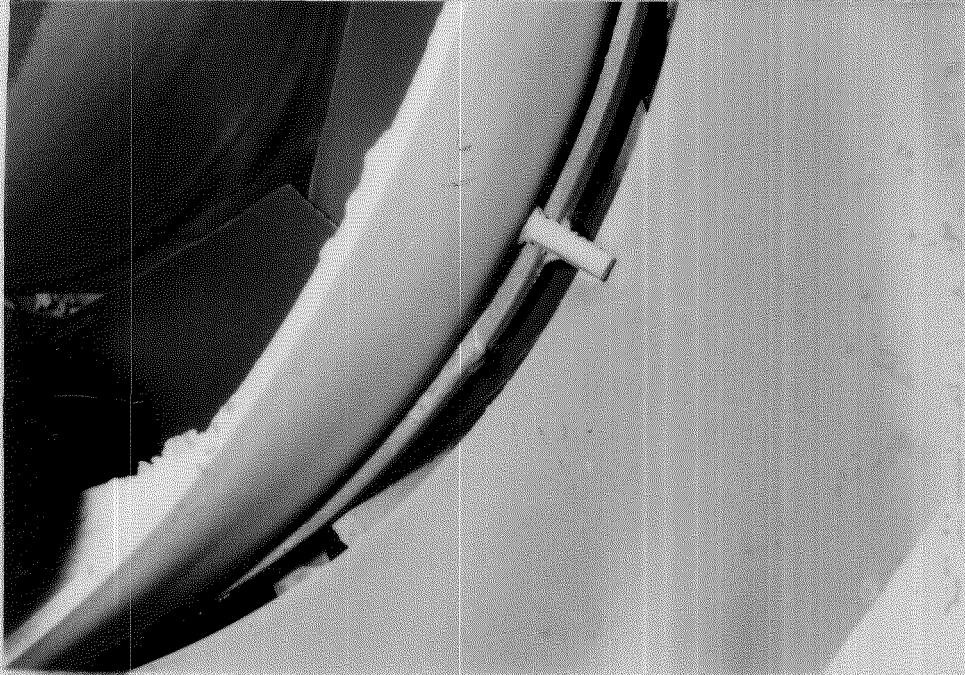
Photo 45 - Excessive clearances around the inner air sleeve where the outer air register assembly has been cut free to allow thermal expansion.

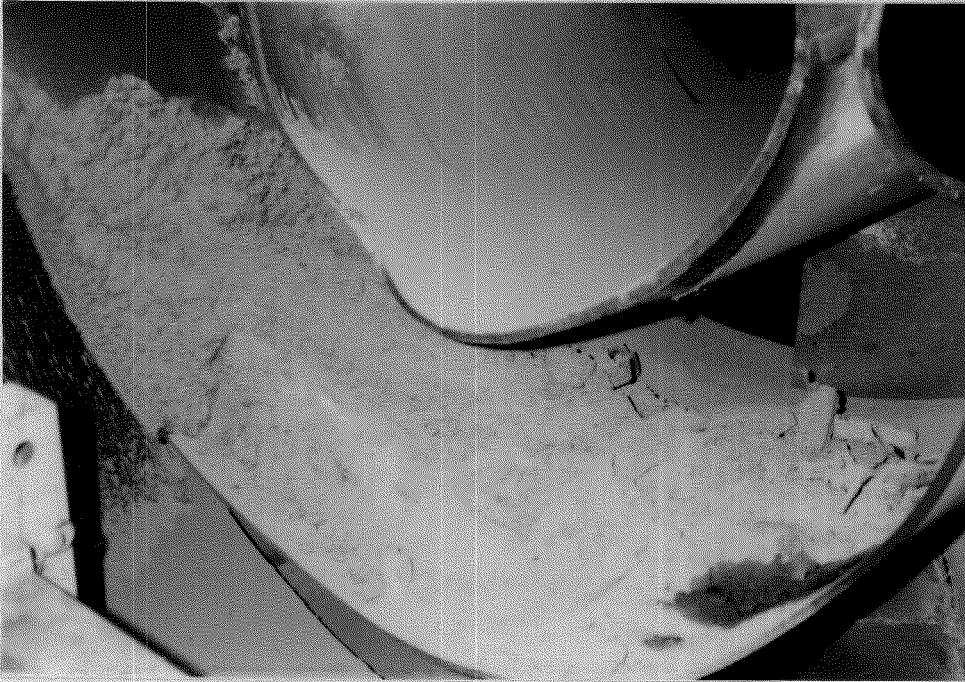
Photo 47 - Fly ash deposits and fallout on inner air sleeve of the burner as shown from fireside of the furnace.

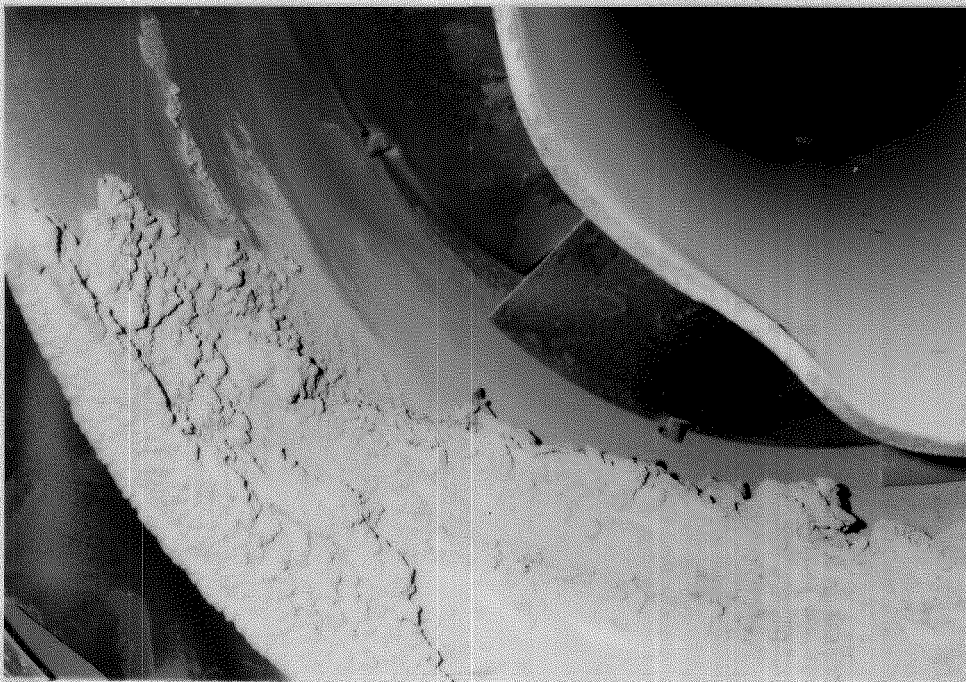
Photo 48 - Inner air sleeve with ash deposits settling on the bottom outer tip.

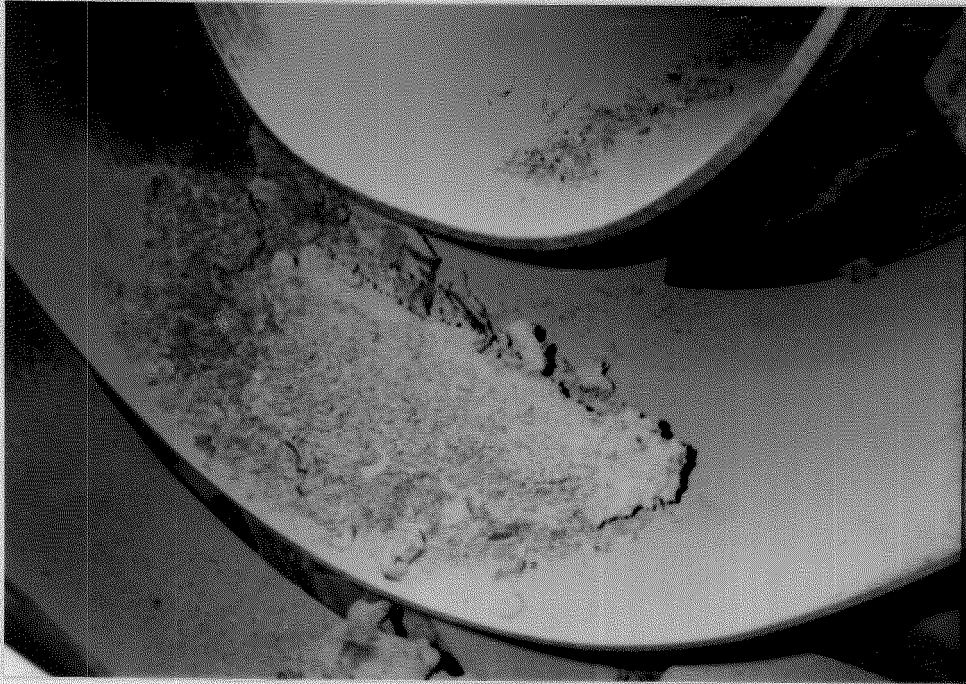
Photo 49 - Deposits on the tip of the inner sleeve of the burner. Note consistency of this ash as opposed to the deposits in Photos 47 through 51.

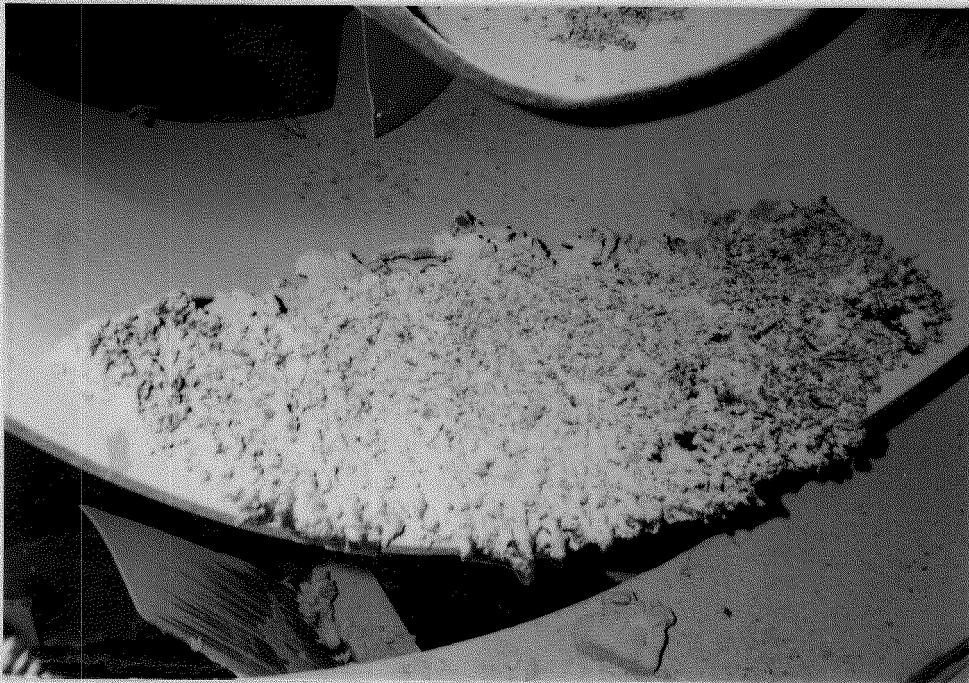
Photo 50 - Deposits on the inner air sleeve of the burner. Note comparison of the deposit which looks like solidified molten coal.

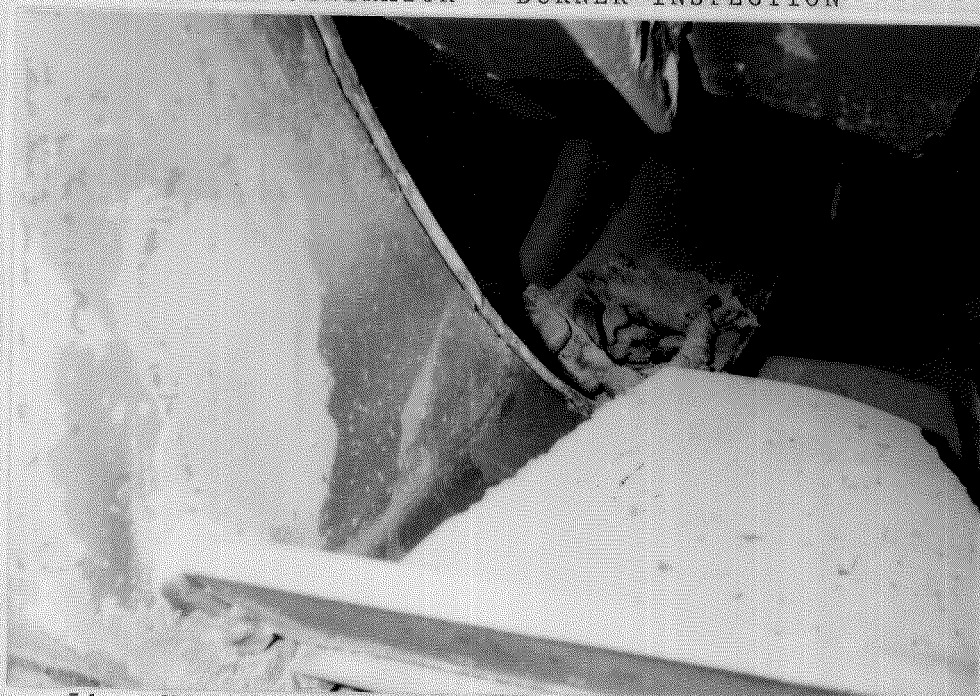
Photo 51 - Windbox view of some deposits on the inner air sleeve. Picture taken through outer air register assembly.

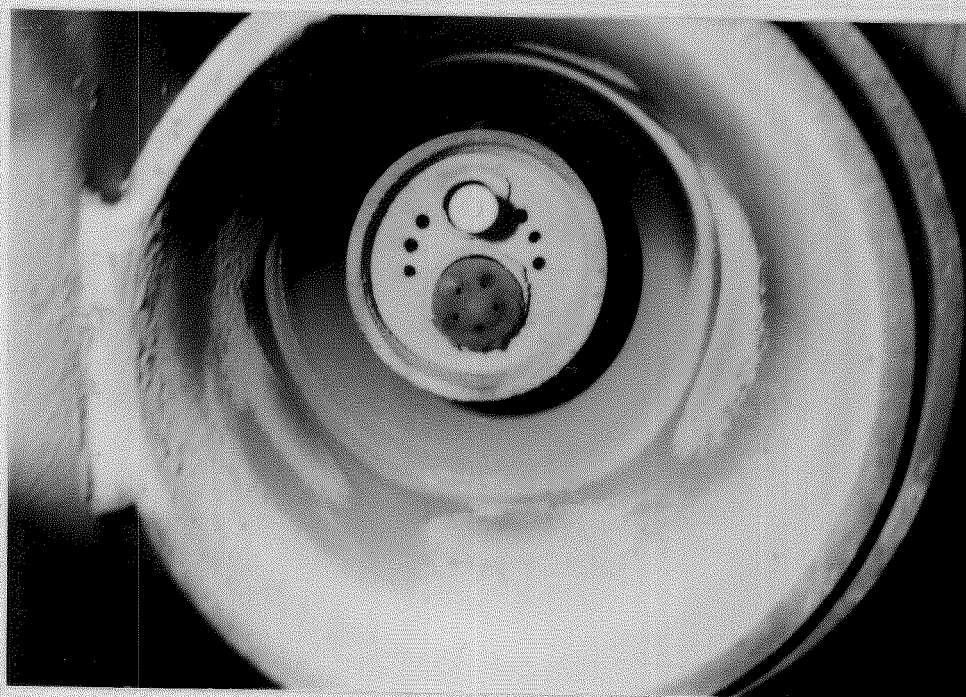
LIGHTERS - Lighters were found to be in extremely dirty condition with fouling and coking very evident. Overheat conditions were also noted with several of the lighter end shields swelling or barreling due to overheating. Two of these assemblies were replaced (Burners 1C03 and 1F04) due to significant damage.

Photo 52 - Lighter assembly in dirty condition. Note fouled

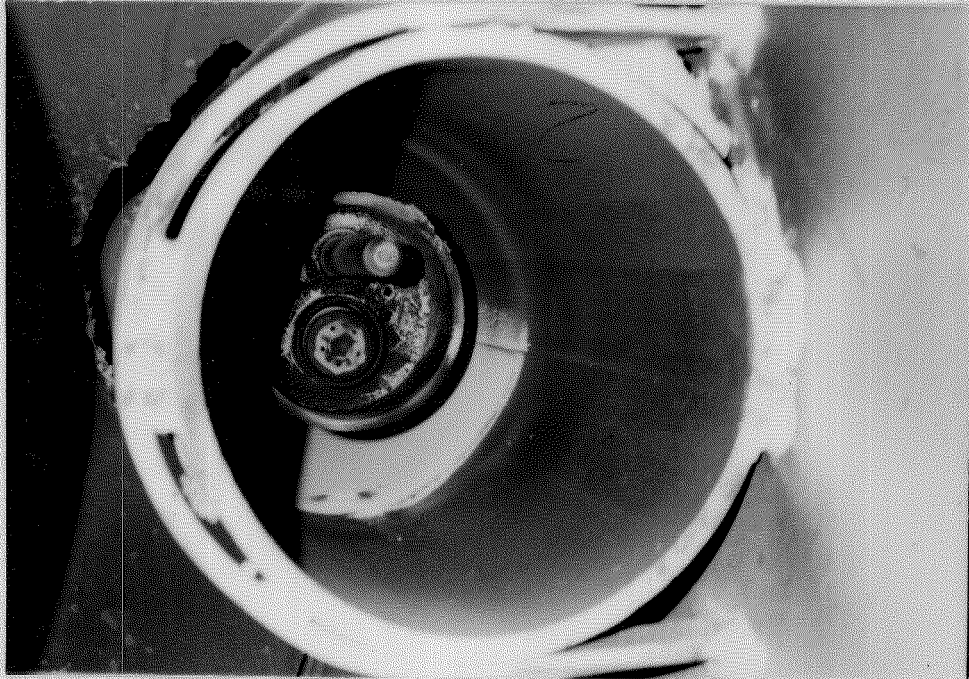
Photo 53 - Dirty lighter assembly that has been coked up possibly due to smoky flame.

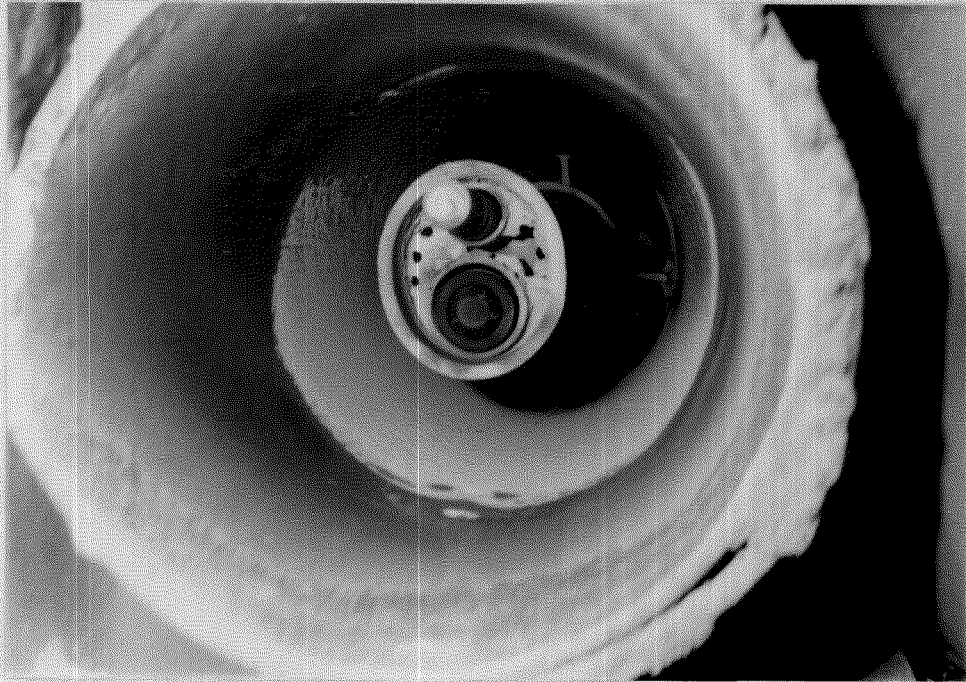
Photo 55 - Lighter with outer shroud overheated and in bell-out or barreled condition. This lighter assembly was replaced.

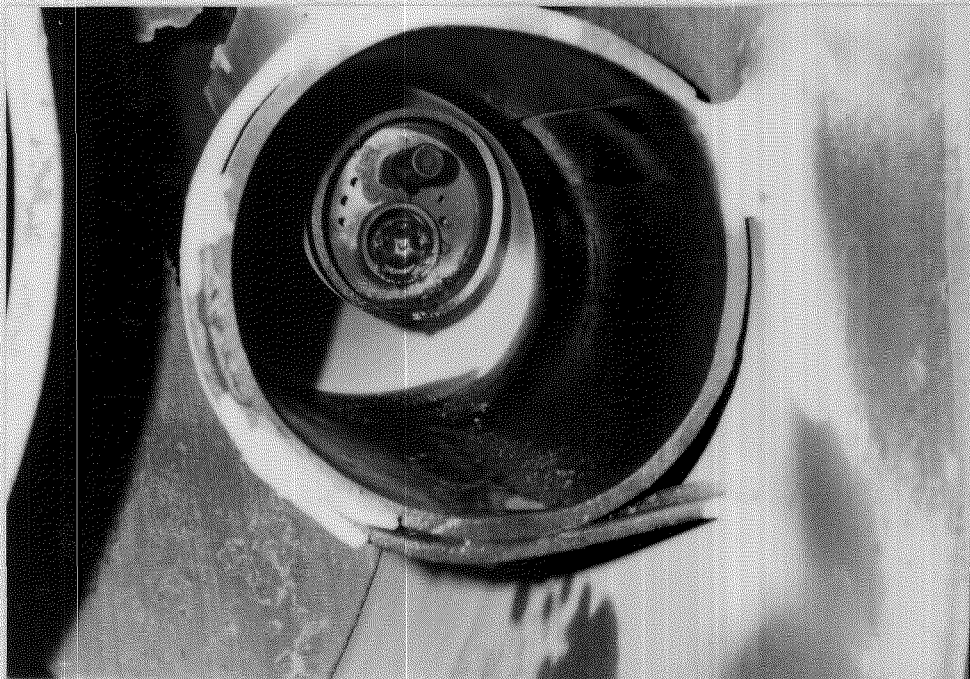
Seven lighters had leaky fuel oil isolation valves which pose a fire potential and safety concern. All identified leaky valves were repaired (reference Photos 52 through 57).

Photo 56 - Lighter with leaky fuel oil shutoff valve. This valve, plus six others, were repaired during the outage.

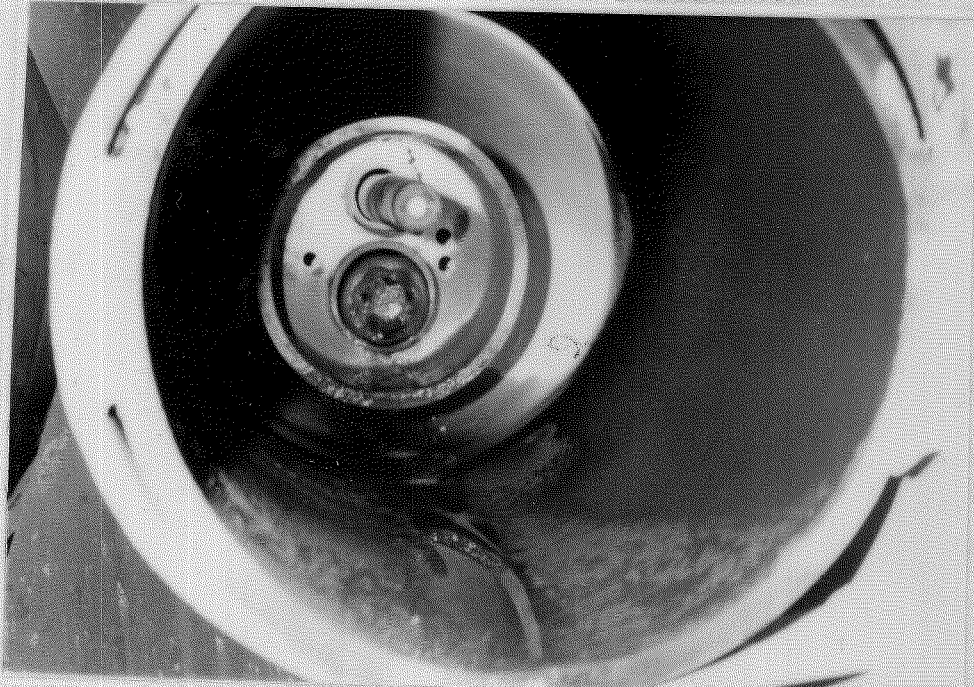
Photo 57 - Lighter with a leaky fuel oil isolation valve posing a fire potential in the lighter shroud.

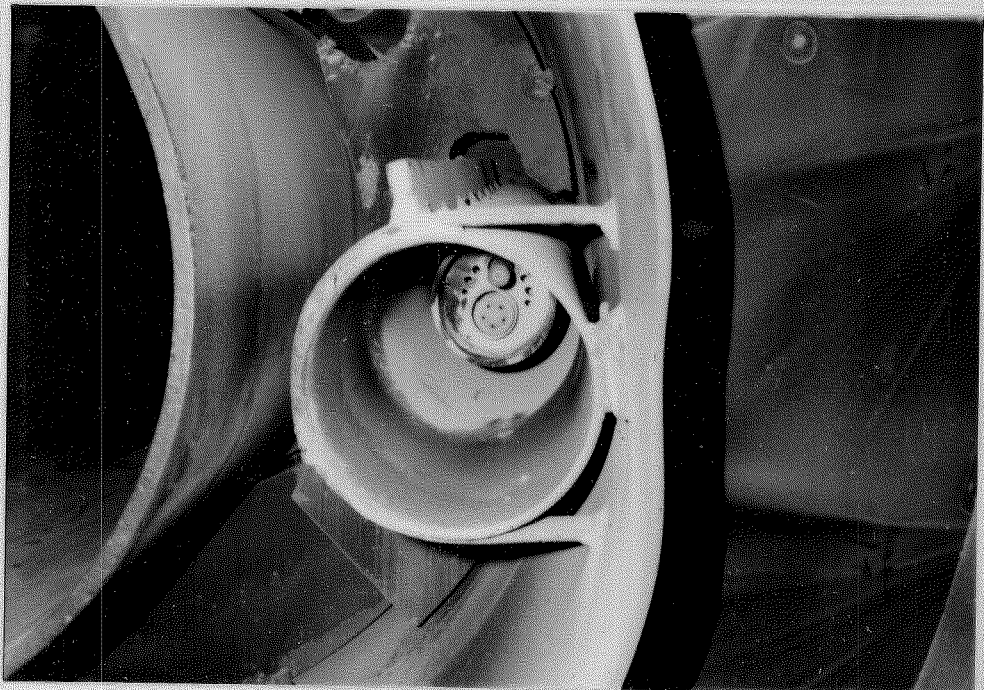
Several U-straps which hold the shroud in place against the inner air sleeve were broken due to overheating and warpage. Severe warpage of the inner air sleeve that was observed, can be attributed to overheating at the lighter shroud attachment at the outer end of the coal nozzle. This attachment weld prevents the shroud from sliding back horizontally which would allow it to fall forward out of the front U-bracket support, which has occurred in the past (reference Photos 58 through 60).

Photo 58 - Lighter shroud, which goes around the lighter assembly to prevent overheating, has caused warping to air sleeve due to an overheat condition.

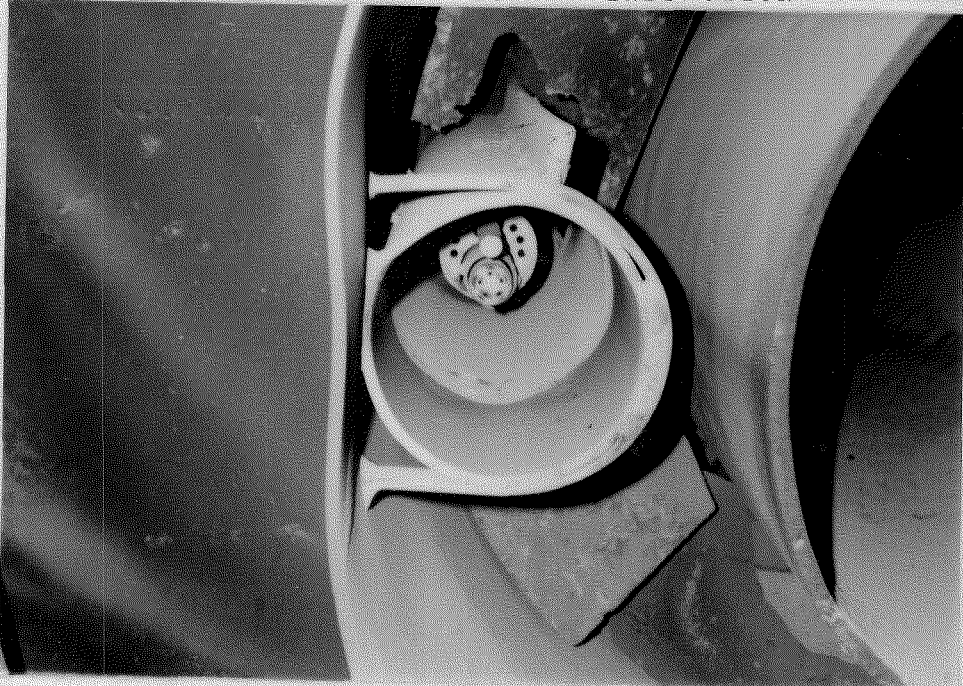
Photo 59 - Lighter shroud which has broken its U-strap attachment to the inner air sleeve due to overheat condition and warpage.

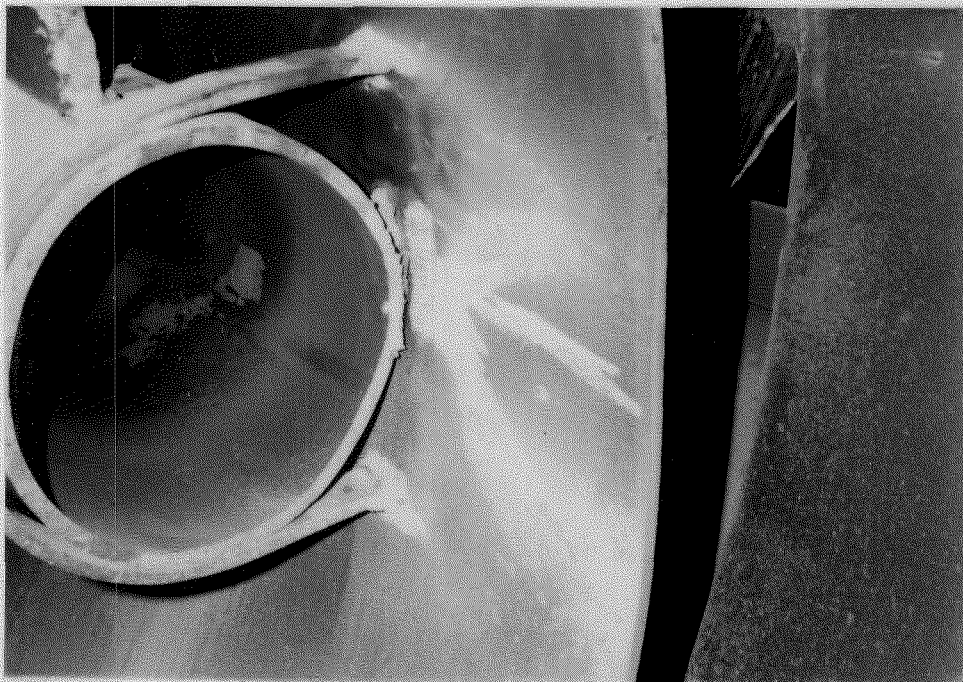
Photo 60 - Broken attachment weld on lighter shroud to inner air sleeve. This attachment which prevents the shroud from sliding horizontally and falling out.

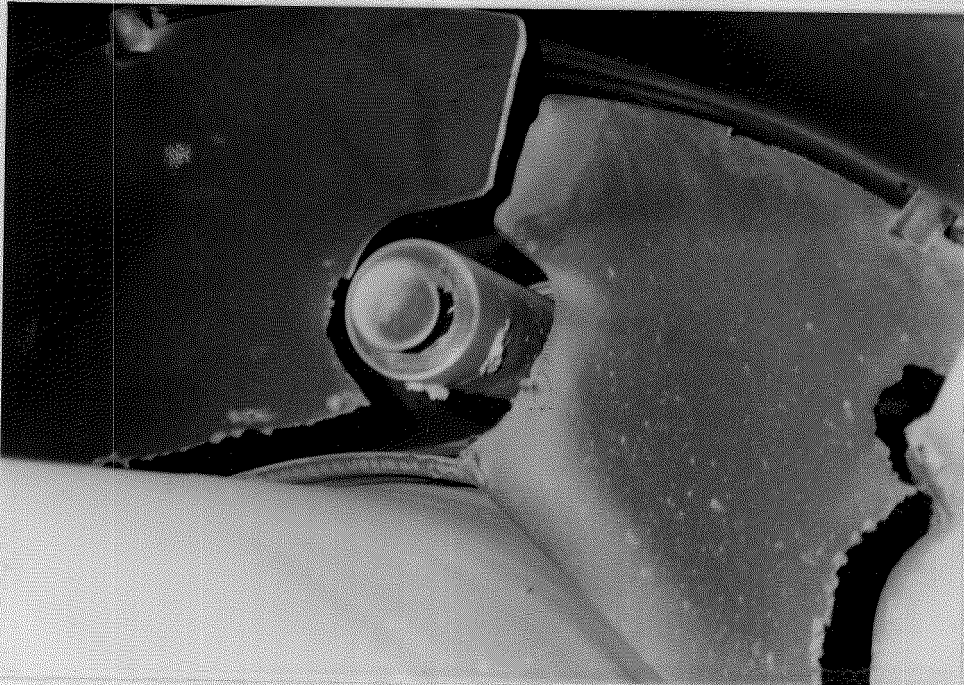
Photo 61 - Scanner in normal operating position. Note how far back from tip of coal nozzle scanner is located (thus realizing some of the difficulties when sighting in scanners for oil and coal flames).

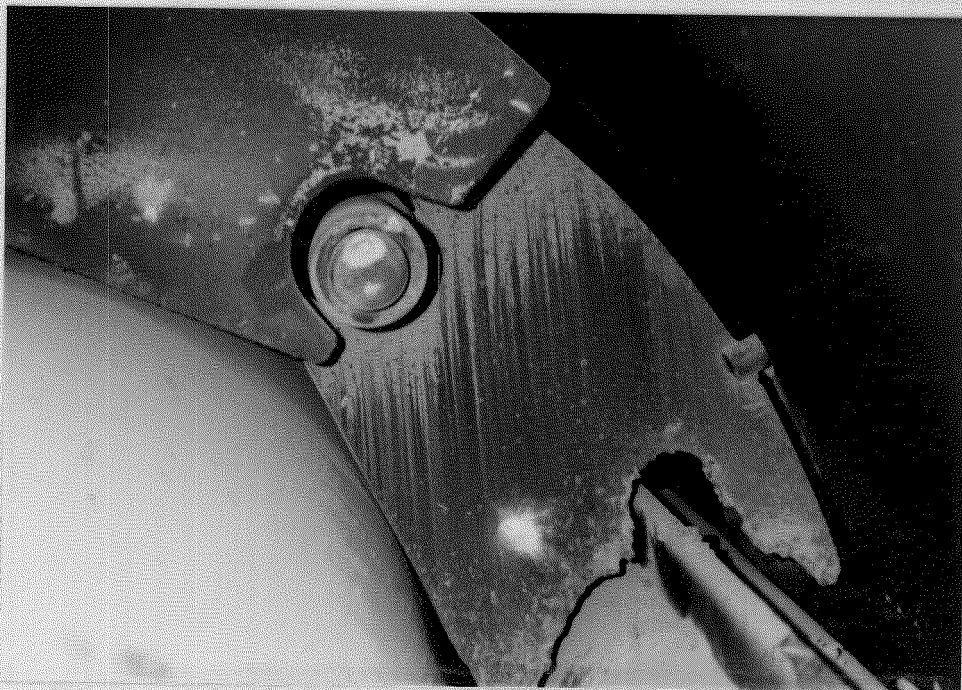
SCANNERS - Buckshot damage was found on one scanner casing due to eyebrows and clinkers on the furnace waterwalls being shot off to help prevent personal injury from falling objects during outage activities (reference Photos 61 and 62).

Photo 62 - Scanner with buckshot damage occurring when eyebrows and slag are being shot from furnace waterwalls.

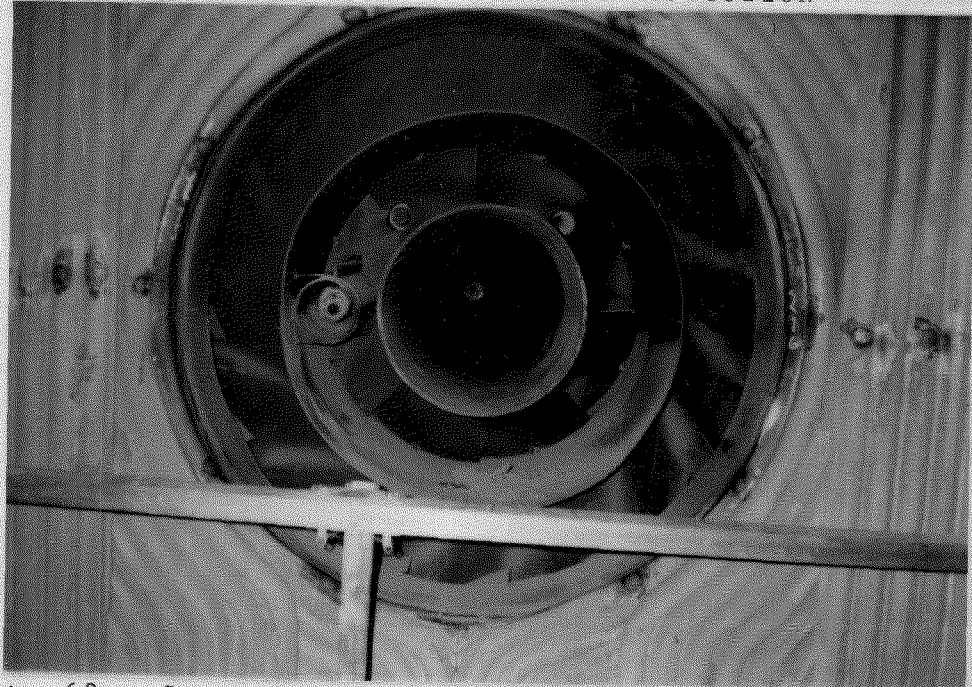
Photo 63 - General status of burner fronts, taken from boiler inspection platform.

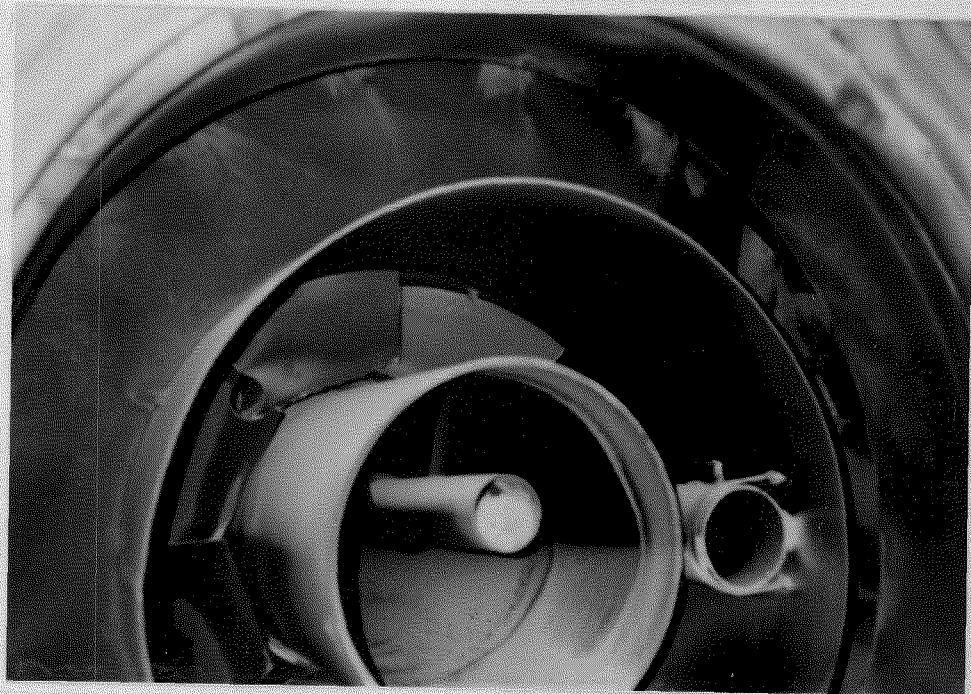
Photo 64 - Close-up angle of burner front showing general status and condition of burner.

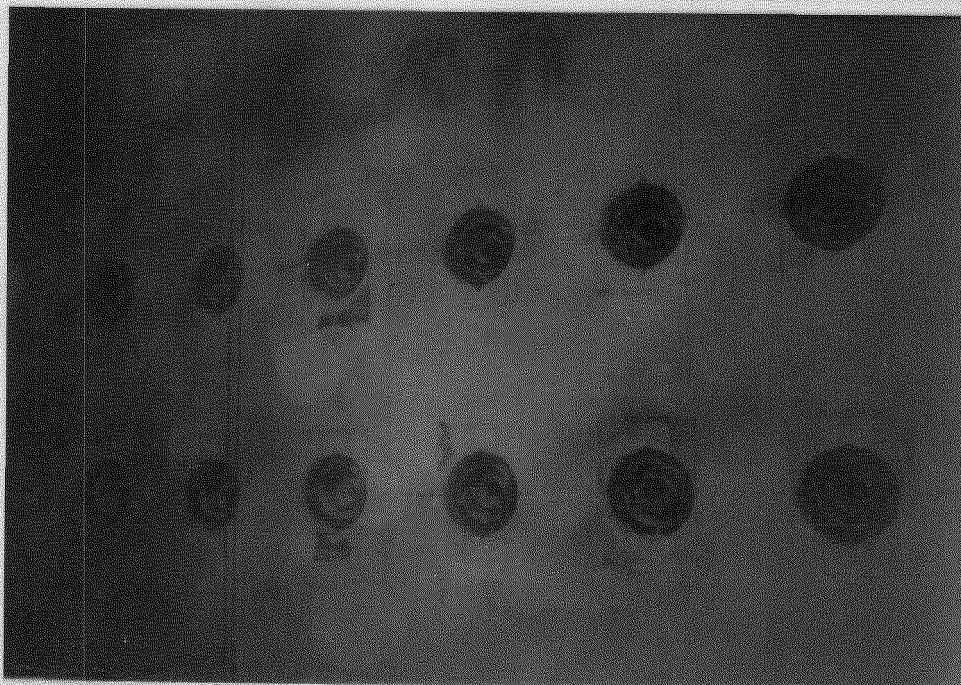
Photo 65 - General condition of burner fronts showing two of the four rows, six across the furnace front.
